ASBESTOS MANAGEMENT PLAN
& PERMIT TO WORK FORMS
FOR
THE HAVANT MENS SHED

FRASER ROAD – HAVANT – PO9 3EJ

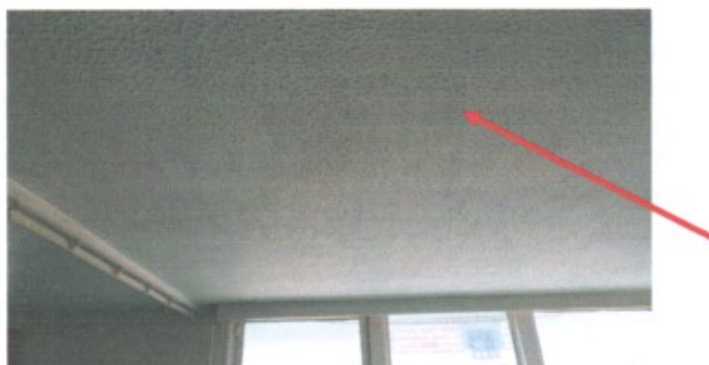
MAIN HALL

Plasterboard Ceilings – this plasterboard was Coated with Artex – PLEASE REFER TO SAMPLE NUMBER - 1 Ref: J001045 – ED000972 taken – This was found to be Positive for Chrysotile (White) Asbestos < 2% Trace of Asbestos & 98% of plaster/water mix – Please refer to Appendix (A) Scopes Bulk Sample Report

PLEASE REFER TO – SAMPLE No (1) - **CHRYBOTILE (WHITE) ASBESTOS** FIBRES WERE NOTED WITHIN THE ARTEX TO THE CEILING WITHIN THIS AREA

THIS WAS ASBESTOS ARTEX MATERIAL – THIS PRODUCT MATERIAL GENERALLY HAS A TRACE ELEMENT OF < 2% OF ASBESTOS FIBRES WITHIN THE MATRIX OF THIS ARTEX MIX

No works to be done within this area of the building by staff or outside contractors unless they have been shown the register and signed to say that no works will be carried out to these materials or in close proximity without written confirmation - **Manage/check & document material condition every 12 Months (Documented re-inspections).**

Remove prior to all/any major refurbishment or demolition to the Artex on the plasterboard ceiling areas of this building.

These works will need to be completed under fully controlled conditions, within an enclosure area, formed to incorporate and enclose these materials, these works will need to be maintained under negative pressure and accessed through a minimum of a 2-stage airlock. There is not a legal requirement for the provision for the attendances of an Analyst from an Independent UKAS accredited Laboratory to undertake reassurance air testing on completion – a signed cleanliness and completion certificate – from the Senior Supervisor for these works for the handover back to the client will be sufficient; in accordance with the HSE ACoP L143, ensuring compliance with CAR 2012; this waste to be transported and disposed of as asbestos waste, direct to a Licensed waste disposal site, by a Registered Carrier, under a Consignment Note, all in accordance with The Hazardous waste (England & Wales) Regulations 2011.

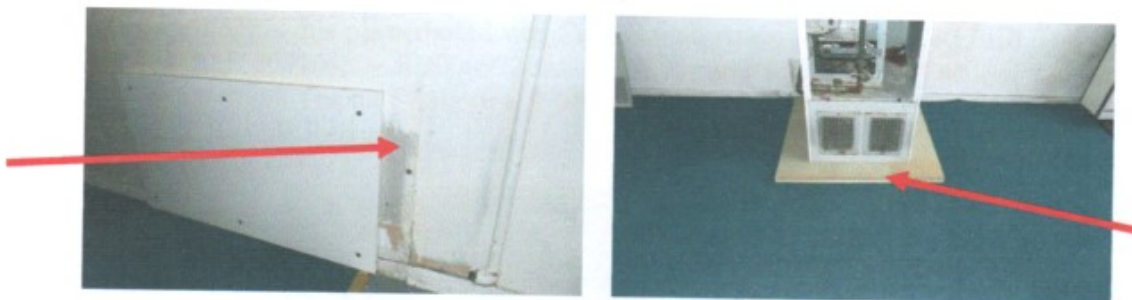
Some insulating board old wall heater panels were noted within this area – A Sample No 3 Ref: J001045 – ED000974 was taken from these panels – This was Positive for Amosite (Brown) Asbestos < 60% Asbestos & 40% cement/plaster mix – Please refer to Appendix (A) Scopes Bulk Sample Report

Some panels were completely over boarded with timber and some were partially over boarded with timber all panels were in good condition and encapsulated/painted

ASBESTOS INSULATING BOARD – OLD WALL HEATER PANELS & EXISTING BLOWER HEATER - INTERNAL – WALLS & FLOOR

PLEASE REFER TO – SAMPLE No (3) - AMOSITE (BROWN) ASBESTOS FIBRES WERE NOTED WITHIN THE WALL & FLOOR PANELS WITHIN THIS AREA

THIS WAS ASBESTOS INSULATING BOARD MATERIAL – THIS PRODUCT MATERIAL GENERALLY HAS < 60% ASBESTOS & > 40% CEMENT/PLASTER MIX

No works to be done within this area of the building by staff and outside contractors unless they have been shown the register and signed to say that no works will be carried out to these materials or in close proximity without written conformation - Manage/check & document material condition every 6 Months (Documented re-inspections).

Remove prior to all/any major refurbishment or demolition to the wall or floor areas

These works must be carried out by a licensed asbestos removal contractor only

These works will need to be completed under fully controlled conditions, within an enclosure area, formed to incorporate and enclose these materials, these works will need to be maintained under negative pressure and accessed through a 3 stage airlock. An independent UKAS accredited analytical company will need to perform a 4 stage clearance for these works all in accordance with the HSE ACoP L143, ensuring compliance with CAR 2012; for the waste disposal - this waste will need to be transported and disposed of as asbestos waste, direct to a Licensed waste disposal site, by a Registered Carrier, under an E.A Consignment Note, all in accordance with The Hazardous waste (England & Wales) Regulations 2011.

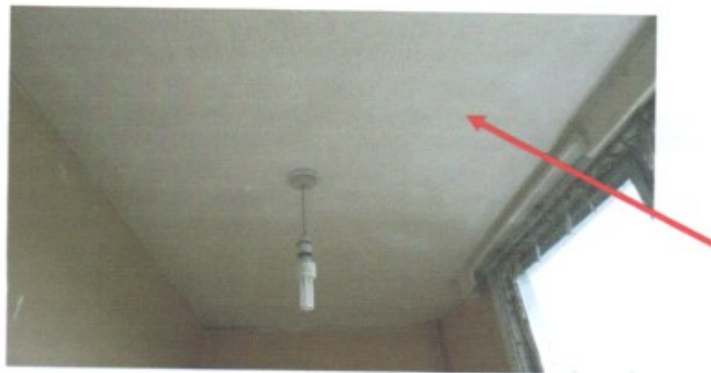
STORE ROOM

Plasterboard Ceilings – this plasterboard was Coated with Artex – PLEASE REFER TO SAMPLE NUMBER - 1 Ref: J001045 – ED000972 taken – This was found to be Positive for Chrysotile (White) Asbestos < 2% Trace of Asbestos & 98% of plaster/water mix – Please refer to Appendix (A) Scopes Bulk Sample Report

PLEASE REFER TO – SAMPLE No (1) - **CHRYSTILE (WHITE) ASBESTOS** FIBRES WERE NOTED WITHIN THE ARTEX TO THE CEILING WITHIN THIS AREA

THIS WAS ASBESTOS ARTEX MATERIAL – THIS PRODUCT MATERIAL GENERALLY HAS A TRACE ELEMENT OF < 2% OF ASBESTOS FIBRES WITHIN THE MATRIX OF THIS ARTEX MIX

No works to be done within this area of the building by staff and outside contractors unless they have been shown the register and signed to say that no works will be carried out to these materials or in close proximity without written conformation - **Manage/check & document material condition every 12 Months (Documented re-inspections).**

Remove prior to all/any major refurbishment or demolition to the Artex on the plasterboard ceiling areas of this building.

These works will need to be completed under fully controlled conditions, within an enclosure area, formed to incorporate and enclose these materials, these works will need to be maintained under negative pressure and accessed through a minimum of a 2-stage airlock. There is not a legal requirement for the provision for the attendances of an Analyst from an Independent UKAS accredited Laboratory to undertake reassurance air testing on completion – a signed cleanliness and completion certificate – from the Senior Supervisor for these works for the handover back to the client will be sufficient; in accordance with the HSE ACoP L143, ensuring compliance with CAR 2012; this waste to be transported and disposed of as asbestos waste, direct to a Licensed waste disposal site, by a Registered Carrier, under a Consignment Note, all in accordance with The Hazardous waste (England & Wales) Regulations 2011.

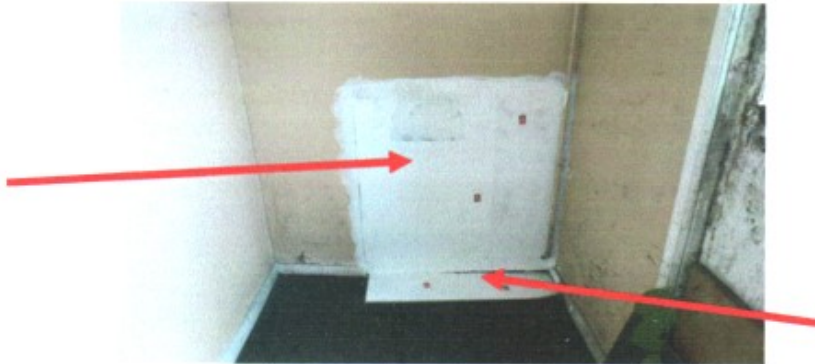
Some insulating board old wall heater panels were noted within this area – A Sample No 3 Ref: J001045 – ED000974 was taken from the shuttering panels – This was Positive for Amosite (Brown) Asbestos < 60% Asbestos & 40% cement/plaster mix – Please refer to Appendix (A) Scopes Bulk Sample Report

Some panels were completely over boarded with timber and some were partially over boarded with timber

ASBESTOS INSULATING BOARD – OLD WALL HEATER PANELS - INTERNAL – WALLS & FLOOR

PLEASE REFER TO – SAMPLE No (3) - **AMOSITE (BROWN) ASBESTOS** FIBRES WERE NOTED WITHIN THE WALL & FLOOR PANELS WITHIN THIS AREA

THIS WAS ASBESTOS INSULATING BOARD MATERIAL – THIS PRODUCT MATERIAL GENERALLY HAS < 60% ASBESTOS & > 40% CEMENT/PLASTER MIX

No works to be done within this area of the building by staff and outside contractors unless they have been shown the register and signed to say that no works will be carried out to these materials or in close proximity without written confirmation - **Manage/check & document material condition every 6 Months (Documented re-inspections).**

Remove prior to all/any major refurbishment or demolition to the wall or floor areas

These works must be carried out by a licensed asbestos removal contractor only

These works will need to be completed under fully controlled conditions, within an enclosure area, formed to incorporate and enclose these materials, these works will need to be maintained under negative pressure and accessed through a 3 stage airlock. An independent UKAS accredited analytical company will need to perform a 4 stage clearance for these works all in accordance with the HSE ACoP L143, ensuring compliance with CAR 2012; for the waste disposal - this waste will need to be transported and disposed of as asbestos waste, direct to a Licensed waste disposal site, by a Registered Carrier, under an E.A Consignment Note, all in accordance with The Hazardous waste (England & Wales) Regulations 2011.

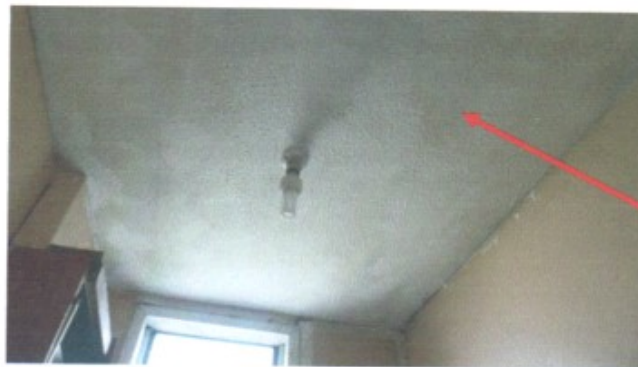
MALE W/C

Plasterboard Ceilings – this plasterboard was Coated with Artex – PLEASE REFER TO SAMPLE NUMBER - 1 Ref: J001045 – ED000972 taken – This was found to be Positive for Chrysotile (White) Asbestos < 2% Trace of Asbestos & 98% of plaster/water mix – Please refer to Appendix (A) Scopes Bulk Sample Report

PLEASE REFER TO – SAMPLE No (1) - **CHRYSTOLE (WHITE) ASBESTOS** FIBRES WERE NOTED WITHIN THE ARTEX TO THE CEILING WITHIN THIS AREA

THIS WAS ASBESTOS ARTEX MATERIAL – THIS PRODUCT MATERIAL GENERALLY HAS A TRACE ELEMENT OF < 2% OF ASBESTOS FIBRES WITHIN THE MATRIX OF THIS ARTEX MIX

No works to be done within this area of the building by staff and outside contractors unless they have been shown the register and signed to say that no works will be carried out to these materials or in close proximity without written conformation - **Manage/check & document material condition every 12 Months (Documented re-inspections).**

Remove prior to all/any major refurbishment or demolition to the Artex on the plasterboard ceiling areas of this building.

These works will need to be completed under fully controlled conditions, within an enclosure area, formed to incorporate and enclose these materials, these works will need to be maintained under negative pressure and accessed through a minimum of a 2-stage airlock. There is not a legal requirement for the provision for the attendances of an Analyst from an Independent UKAS accredited Laboratory to undertake reassurance air testing on completion – a signed cleanliness and completion certificate – from the Senior Supervisor for these works for the handover back to the client will be sufficient; in accordance with the HSE ACoP L143, ensuring compliance with CAR 2012; this waste to be transported and disposed of as asbestos waste, direct to a Licensed waste disposal site, by a Registered Carrier, under a Consignment Note, all in accordance with The Hazardous waste (England & Wales) Regulations 2011.

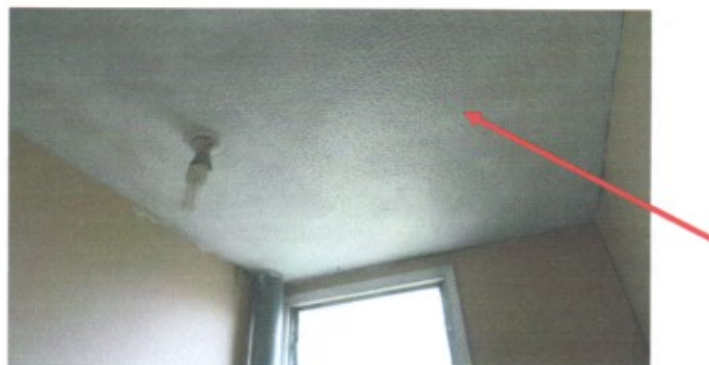
FEMALE W/C

Plasterboard Ceilings – this plasterboard was Coated with Artex – PLEASE REFER TO SAMPLE NUMBER - 1 Ref: J001045 – ED000972 taken – This was found to be Positive for Chrysotile (White) Asbestos < 2% Trace of Asbestos & 98% of plaster/water mix – Please refer to Appendix (A) Scopes Bulk Sample Report

PLEASE REFER TO – SAMPLE No (1) - **CHRYSOTILE (WHITE) ASBESTOS** FIBRES WERE NOTED WITHIN THE ARTEX TO THE CEILING WITHIN THIS AREA

THIS WAS ASBESTOS ARTEX MATERIAL – THIS PRODUCT MATERIAL GENERALLY HAS A TRACE ELEMENT OF < 2% OF ASBESTOS FIBRES WITHIN THE MATRIX OF THIS ARTEX MIX

No works to be done within this area of the building by staff and outside contractors unless they have been shown the register and signed to say that no works will be carried out to these materials or in close proximity without written conformation - **Manage/check & document material condition every 12 Months (Documented re-inspections).**

Remove prior to all/any major refurbishment or demolition to the Artex on the plasterboard ceiling areas of this building.

These works will need to be completed under fully controlled conditions, within an enclosure area, formed to incorporate and enclose these materials, these works will need to be maintained under negative pressure and accessed through a minimum of a 2-stage airlock. There is not a legal requirement for the provision for the attendances of an Analyst from an Independent UKAS accredited Laboratory to undertake reassurance air testing on completion – a signed cleanliness and completion certificate – from the Senior Supervisor for these works for the handover back to the client will be sufficient; in accordance with the HSE ACoP L143, ensuring compliance with CAR 2012; this waste to be transported and disposed of as asbestos waste, direct to a Licensed waste disposal site, by a Registered Carrier, under a Consignment Note, all in accordance with The Hazardous waste (England & Wales) Regulations 2011.

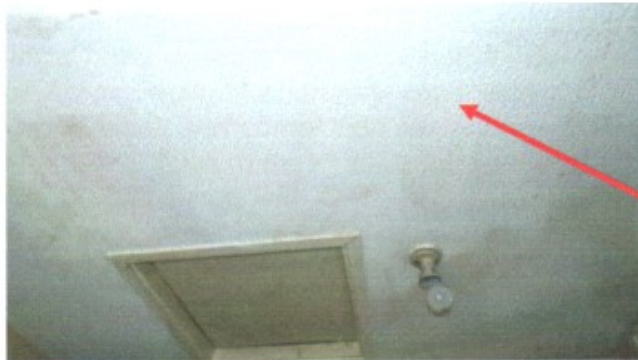
CORRIDOR AREA

Plasterboard Ceilings – this plasterboard was Coated with Artex – PLEASE REFER TO SAMPLE NUMBER - 1 Ref: J001045 – ED000972 taken – This was found to be Positive for Chrysotile (White) Asbestos < 2% Trace of Asbestos & 98% of plaster/water mix – Please refer to Appendix (A) Scopes Bulk Sample Report

PLEASE REFER TO – SAMPLE No (1) - **CHRYSOTILE (WHITE) ASBESTOS** FIBRES WERE NOTED WITHIN THE ARTEX TO THE CEILING WITHIN THIS AREA

THIS WAS ASBESTOS ARTEX MATERIAL – THIS PRODUCT MATERIAL GENERALLY HAS A TRACE ELEMENT OF < 2% OF ASBESTOS FIBRES WITHIN THE MATRIX OF THIS ARTEX MIX

No works to be done within this area of the building by staff and outside contractors unless they have been shown the register and signed to say that no works will be carried out to these materials or in close proximity without written conformation - **Manage/check & document material condition every 12 Months (Documented re-inspections).**

Remove prior to all/any major refurbishment or demolition to the Artex on the plasterboard ceiling areas of this building.

These works will need to be completed under fully controlled conditions, within an enclosure area, formed to incorporate and enclose these materials, these works will need to be maintained under negative pressure and accessed through a minimum of a 2-stage airlock. There is not a legal requirement for the provision for the attendances of an Analyst from an Independent UKAS accredited Laboratory to undertake reassurance air testing on completion – a signed cleanliness and completion certificate – from the Senior Supervisor for these works for the handover back to the client will be sufficient; in accordance with the HSE ACoP L143, ensuring compliance with CAR 2012; this waste to be transported and disposed of as asbestos waste, direct to a Licensed waste disposal site, by a Registered Carrier, under a Consignment Note, all in accordance with The Hazardous waste (England & Wales) Regulations 2011.

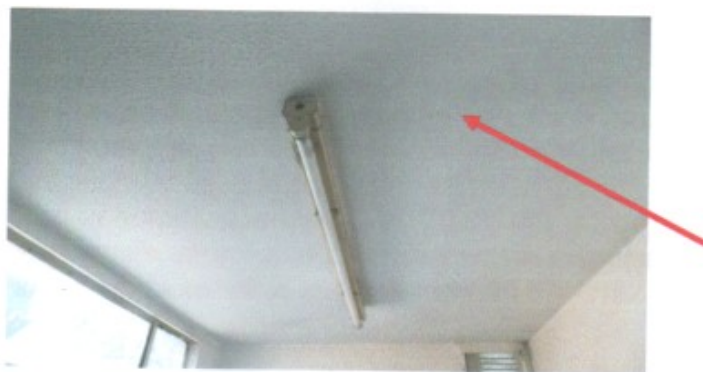
KITCHEN

Plasterboard Ceilings – this plasterboard was Coated with Artex – PLEASE REFER TO SAMPLE NUMBER - 1 Ref: J001045 – ED000972 taken – This was found to be Positive for Chrysotile (White) Asbestos < 2% Trace of Asbestos & 98% of plaster/water mix – Please refer to Appendix (A) Scopes Bulk Sample Report

PLEASE REFER TO – SAMPLE No (1) - **CHRYSTILE (WHITE) ASBESTOS** FIBRES WERE NOTED WITHIN THE ARTEX TO THE CEILING WITHIN THIS AREA

THIS WAS ASBESTOS ARTEX MATERIAL – THIS PRODUCT MATERIAL GENERALLY HAS A TRACE ELEMENT OF < 2% OF ASBESTOS FIBRES WITHIN THE MATRIX OF THIS ARTEX MIX

No works to be done within this area of the building by staff or outside contractors unless they have been shown the register and signed to say that no works will be carried out to these materials or in close proximity without written conformation - **Manage/check & document material condition every 12 Months (Documented re-inspections).**

Remove prior to all/any major refurbishment or demolition to the Artex on the plasterboard ceiling areas of this building.

These works will need to be completed under fully controlled conditions, within an enclosure area, formed to incorporate and enclose these materials, these works will need to be maintained under negative pressure and accessed through a minimum of a 2-stage airlock. There is not a legal requirement for the provision for the attendances of an Analyst from an Independent UKAS accredited Laboratory to undertake reassurance air testing on completion – a signed cleanliness and completion certificate – from the Senior Supervisor for these works for the handover back to the client will be sufficient; in accordance with the HSE ACoP L143, ensuring compliance with CAR 2012; this waste to be transported and disposed of as asbestos waste, direct to a Licensed waste disposal site, by a Registered Carrier, under a Consignment Note, all in accordance with The Hazardous waste (England & Wales) Regulations 2011.

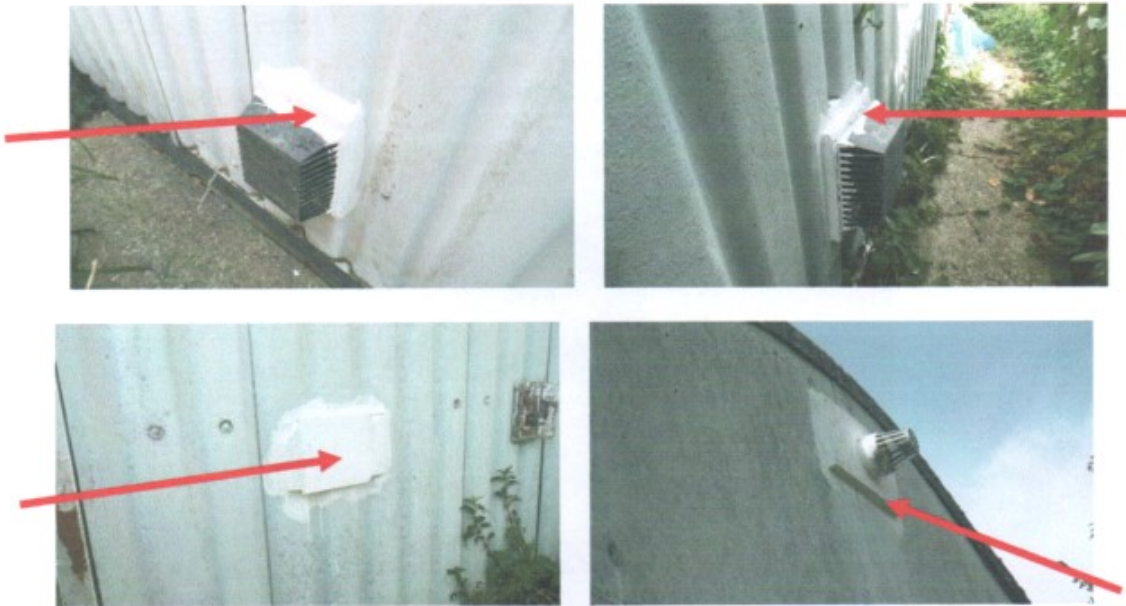
Some insulating board old wall heater flue panels were noted within this area – A Sample No 4 Ref: J001045 – ED000975 was taken from these panels – This was Positive for Amosite (Brown) Asbestos < 60% Asbestos & 40% cement/plaster mix – Please refer to Appendix (A) Scopes Bulk Sample Report

All panels were painted/encapsulated

ASBESTOS INSULATING BOARD – OLD WALL HEATER FLUE PANELS - EXTERNAL – WALLS

PLEASE REFER TO – SAMPLE No (4) - **AMOSITE (BROWN) ASBESTOS** FIBRES WERE NOTED WITHIN THE WALL & FLUE PANELS WITHIN THIS EXTERNAL AREA

THIS WAS ASBESTOS INSULATING BOARD MATERIAL – THIS PRODUCT MATERIAL GENERALLY HAS < 60% ASBESTOS & > 40% CEMENT/PLASTER MIX

No works to be done within this area of the building by staff or outside contractors unless they have been shown the register and signed to say that no works will be carried out to these materials or in close proximity without written conformation - **Manage/check & document material condition every 6 Months (Documented re-inspections).**

Remove prior to all/any major refurbishment or demolition to the wall or floor areas

These works must be carried out by a licensed asbestos removal contractor only

These works will need to be completed under fully controlled conditions, within an enclosure area, formed to incorporate and enclose these materials, these works will need to be maintained under negative pressure and accessed through a 3 stage airlock. An independent UKAS accredited analytical company will need to perform a 4 stage clearance for these works all in accordance with the HSE ACoP L143, ensuring compliance with CAR 2012; for the waste disposal - this waste will need to be transported and disposed of as asbestos waste, direct to a Licensed waste disposal site, by a Registered Carrier, under an E.A Consignment Note, all in accordance with The Hazardous waste (England & Wales) Regulations 2011.

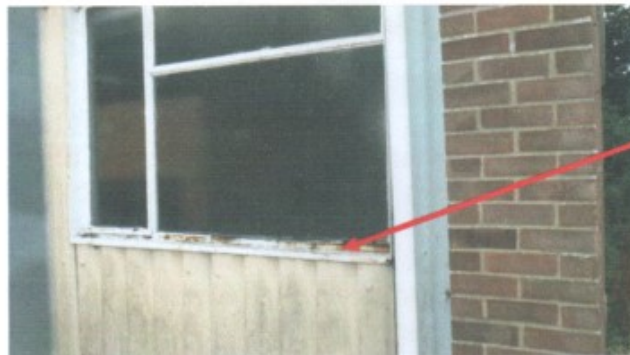
Windows & doors – Putty – PLEASE REFER TO SAMPLE NUMBER - 5 Ref: J001045 – ED000976 taken – This was found to be Positive for Chrysotile (White) Asbestos < 2% Trace of Asbestos & 98% of putty & oil mix – Please refer to Appendix (A) Scopes Bulk Sample Report

PLEASE REFER TO – SAMPLE No (5) - CHRYBOTILE (WHITE) ASBESTOS FIBRES WERE NOTED WITHIN THE PUTTY TO ALL WINDOWS AND DOORS TO THE EXTERNAL AREAS OF THIS BUILDING

THIS WAS ASBESTOS PUTTY MATERIAL – THIS PRODUCT MATERIAL GENERALLY HAS A TRACE ELEMENT OF < 2% OF ASBESTOS FIBRES WITHIN THE MATRIX OF THIS MATERIAL

No works to be done within this area of the building by staff or outside contractors unless they have been shown the register and signed to say that no works will be carried out to these materials or in close proximity without written confirmation - **Manage/check & document material condition every 12 Months (Documented re-inspections).**

Remove prior to all/any major refurbishment or demolition to the windows and door areas of this building.

These works will need to be completed under controlled conditions, within a restricted access area only, formed to incorporate these materials, putty & metal window/door frames will need to be removed whole/intact as much as possible – window frames & doors with the putty will need to be wrapped in 1000g polythene and labelled to contain asbestos. There is not a legal requirement for the provision for the attendances of an Analyst from an Independent UKAS accredited Laboratory to undertake reassurance air testing on completion – a signed cleanliness and completion certificate – from the Senior Supervisor for these works for the handover back to the client will be sufficient; all in accordance with the HSE ACOP L143, ensuring compliance with CAR 2012; this waste to be transported and disposed of as asbestos waste, direct to a Licensed waste disposal site, by a Registered Carrier, under a Consignment Note, all in accordance with The Hazardous waste (England & Wales) Regulations 2011.

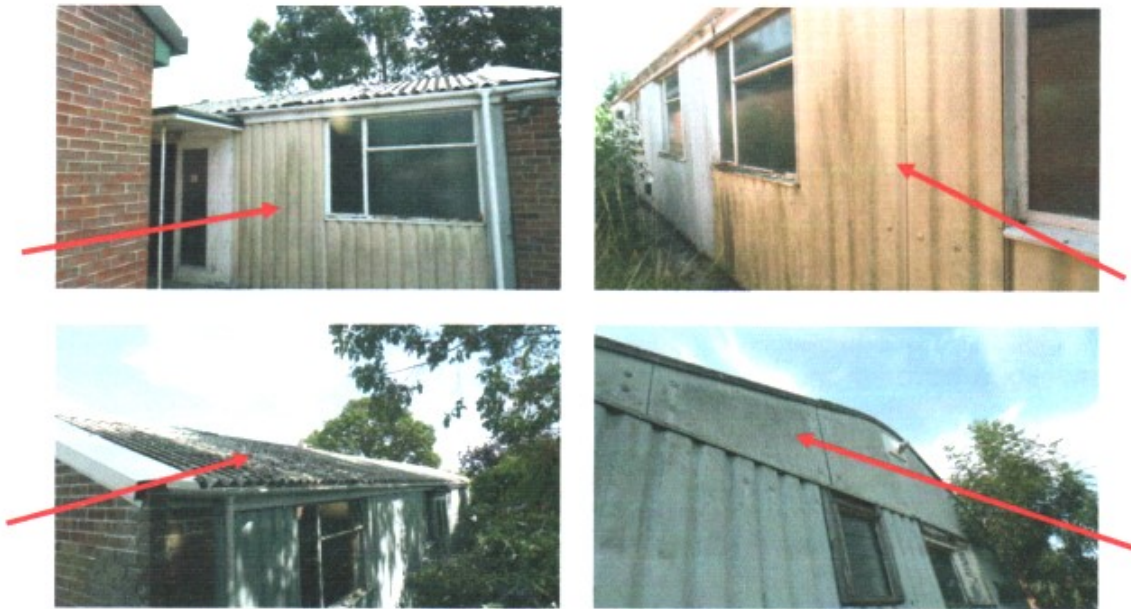
Walls/gable end & all roof sheets have been found to contain Asbestos Cement – **PLEASE REFER TO SAMPLE NUMBERS – 7 & 9 Ref: J001045 – ED000978/980 taken – These were found to be Positive for Chrysotile (White) Asbestos Cement < 10% of Asbestos & 90% of Keans Cement mix – Please refer to Appendix (A) Scopes Bulk Sample Report**

ASBESTOS CEMENT WALL GABLE END AND CORRUGATED ROOF SHEETS

PLEASE REFER TO – SAMPLE No (7 & 9) - **CHRYSTILE (WHITE) ASBESTOS** FIBRES WERE NOTED WITHIN THE CEMENT WALL SHEETS GABLE END WALL PANELS & CORRUGATED ROOF SHEETS TO THE EXTERNAL AREAS OF THIS BUILDING

No works to be done within this area of the building by staff or outside contractors unless they have been shown the register and signed to say that no works will be carried out to these materials or in close proximity without written confirmation - **Manage/check & document material condition every 12 Months (Documented re-inspections).**

These works will need to be completed under controlled conditions, within a restricted access area only, formed to incorporate these materials, all wall and roof sheets will need to have the retaining bolts cut with bolt croppers all sheets to be removed whole/intact as much as possible – all sheets removed will need to be wrapped in 1000g polythene and labelled to contain asbestos if disposal is from a van/vehicle – if an Asbestos Cement Skip is hired normally no wrapping of the sheets is necessary advice will need to be asked of the skips management team. There is not a legal requirement for the provision for the attendances of an Analyst from an Independent UKAS accredited Laboratory to undertake reassurance air testing on completion – a signed cleanliness and completion certificate – from the Senior Supervisor for these works for the handover back to the client will be sufficient; all in accordance with the HSE ACOP L143, ensuring compliance with CAR 2012; this waste to be transported and disposed of as asbestos waste, direct to a Licensed waste disposal site, by a Registered Carrier, under a Consignment Note, all in accordance with The Hazardous waste (England & Wales) Regulations 2011.
